IBM Customer Engineering

SERVICE INDEX

Sorter

IBM 083 SERVICE INDEX

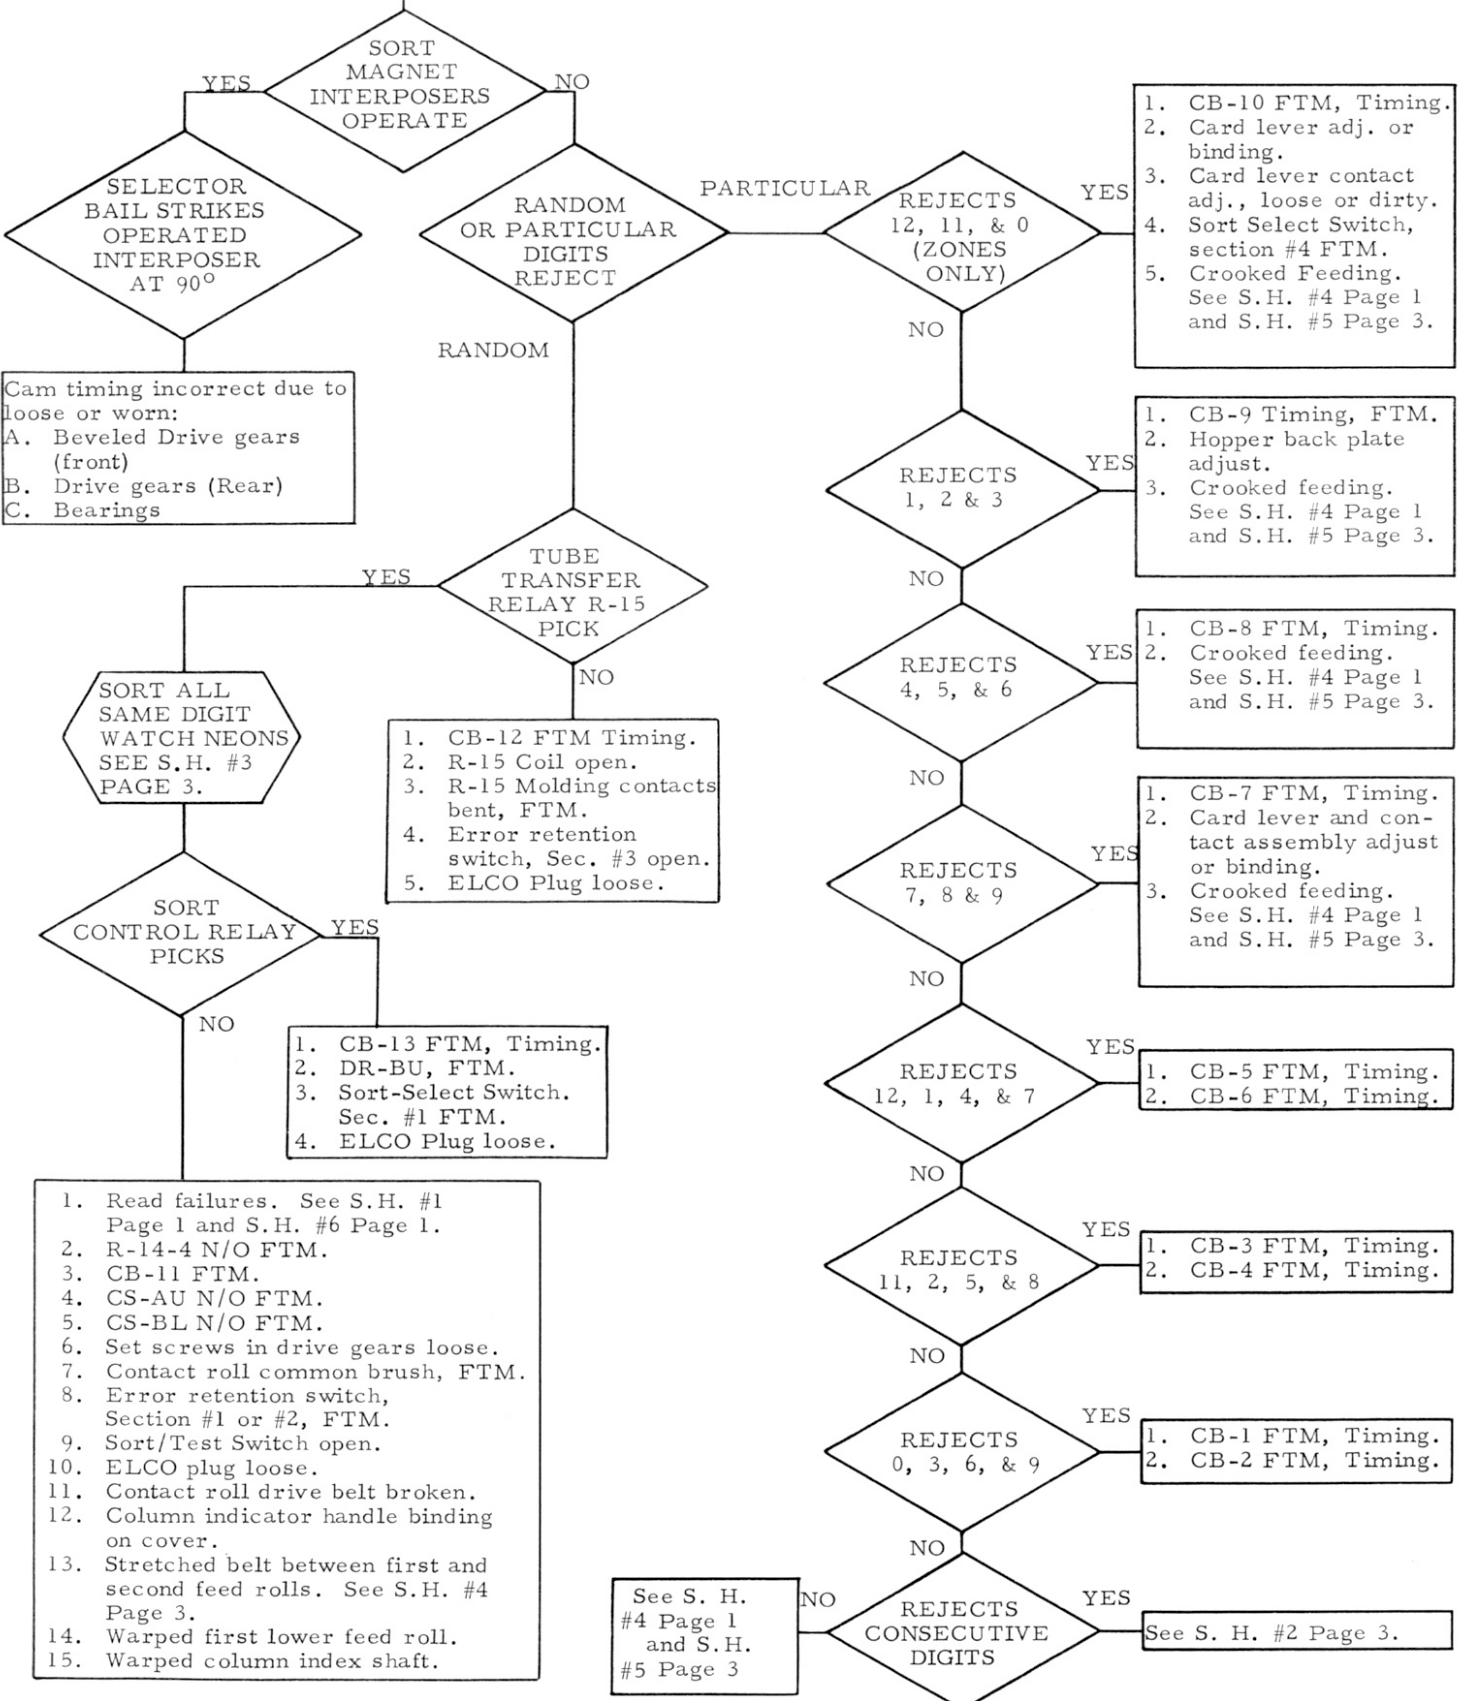
REJECTING RANDOM OR PARTICULAR DIGITS

SET SORT-SELECT SWITCH ON 'N' AND CHECK SORT BRUSH FOR TRACKING, TIMING, LOOSENESS, AND WEAR SEE S.H. #1 PAGE 1 AND S.H. #6 PAGE 1.

FOR INTERMITTENT REJECTING SEE S.H. #1 PAGE 3 AND S.H. #3 PAGE 4.

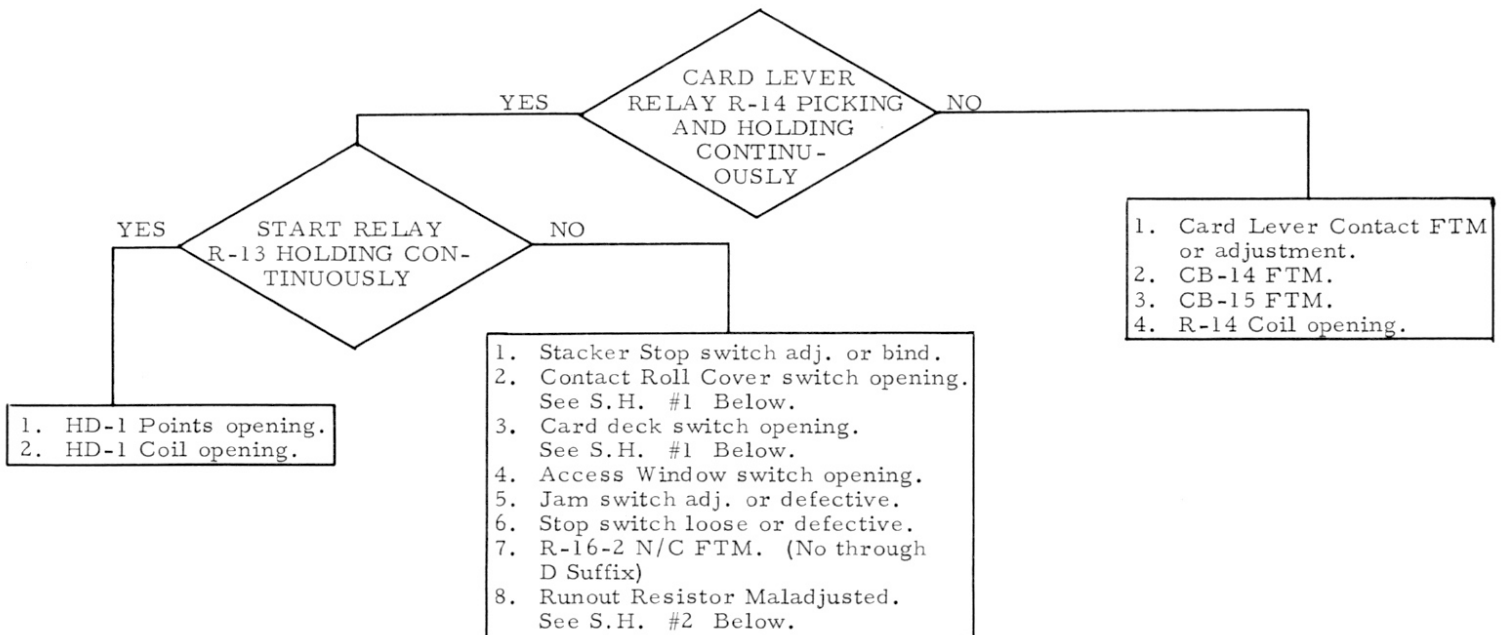
STOPPING

S.H. #1. Loose or maladjusted card deck or contact roll cover can cause stopping when cards are being joggled. Their respective switches may be properly adjusted, but the cover may cause them to open.

S.H. #2. Adjust the run out time for one-half to one second after the last 9 card drops into the 9 pocket. The Run-Out Resistor is located directly behind the power supply terminal strip.

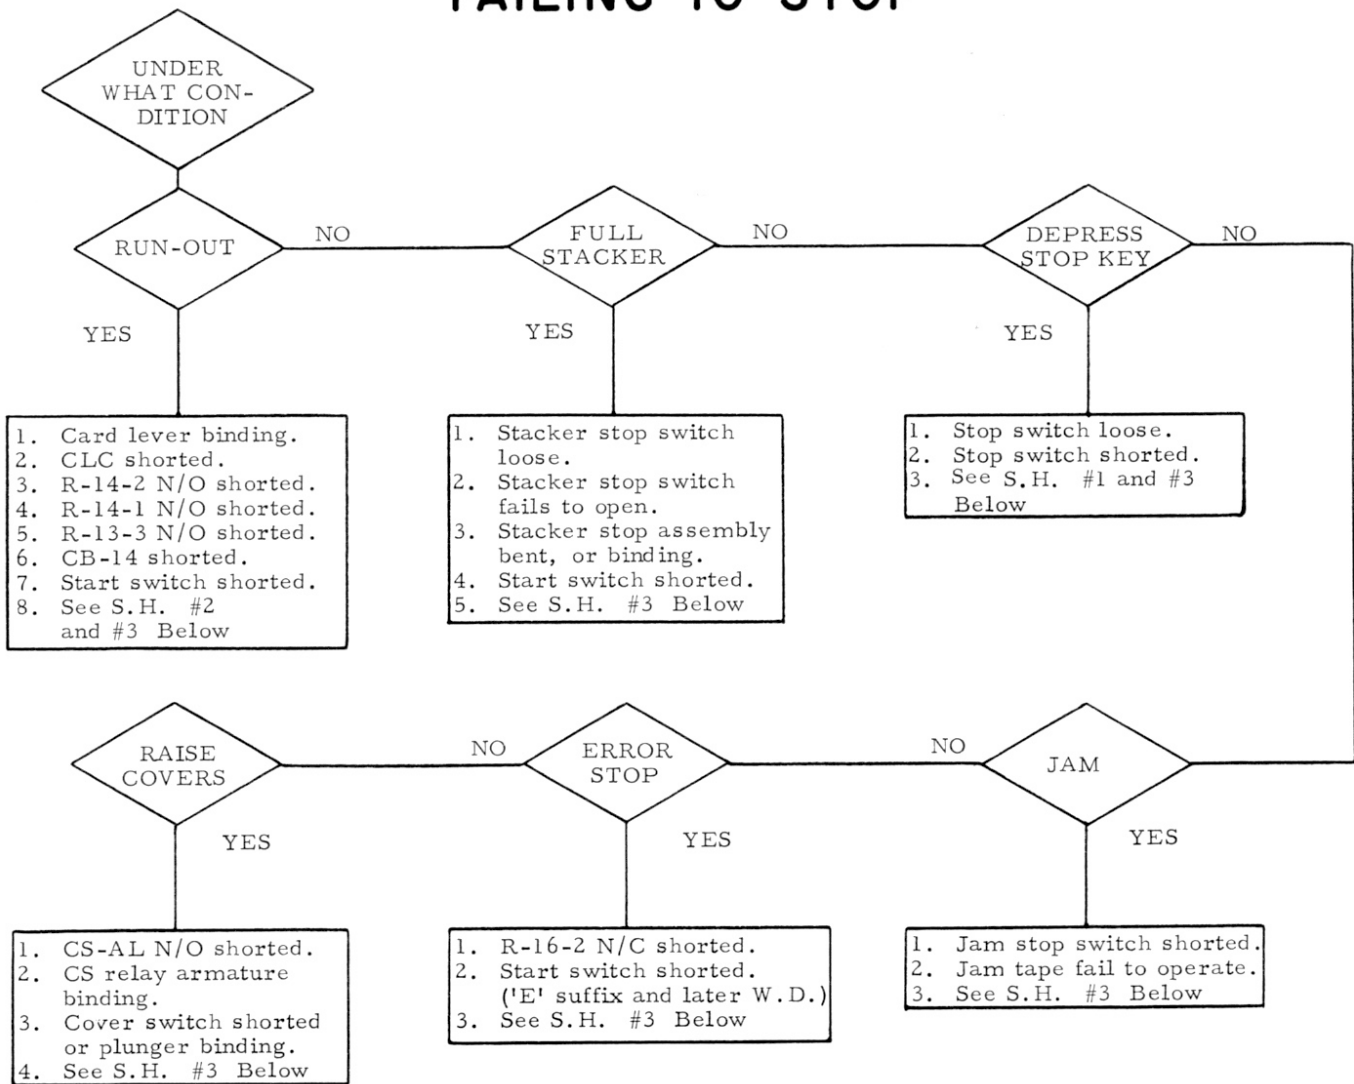
FAILING TO STOP

S.H. #1. Stopping, but restarting when the stop key is released can be caused by a shorted start switch or, if cards are in the machine, by shorted R-13-1 N/O points.

S.H. #2. If machine fails to stop immediately upon running out, adjust Run-Out resistor directly behind Power Supply Terminal Strip. Adjust to stop machine one half to one second after the last nine punched card is in the stacker.

1. R-13-2 N/C fail to make.
2. HD-2 points fail to make.
3. HD-2 coil open.

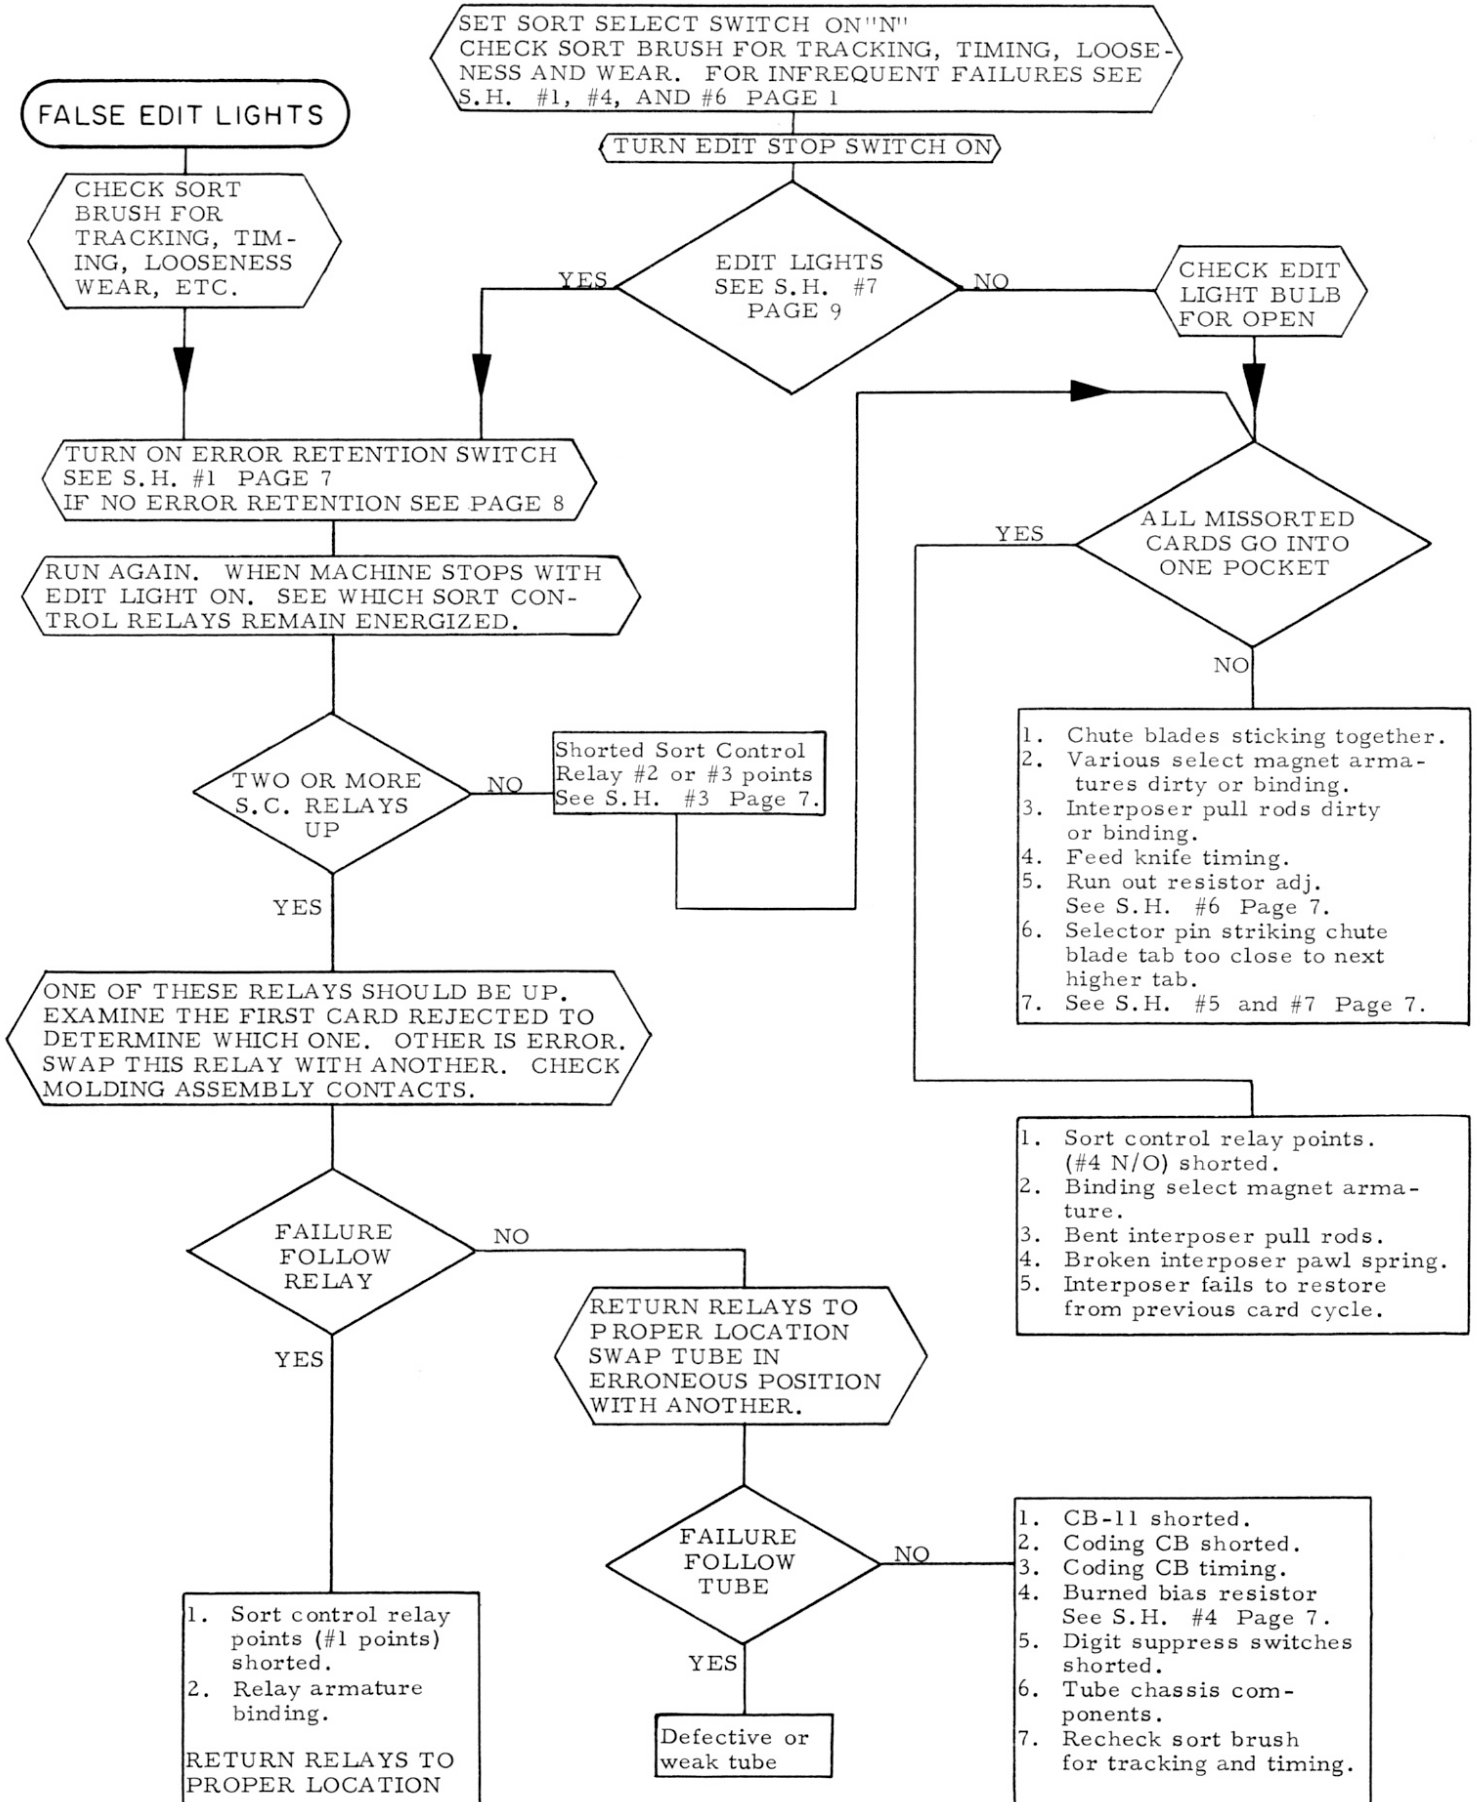
MISSORTING MACHINES WITH ERROR RETENTION

S.H. #3. In this case, edit lights were false. Shorted points might not cause failures if customer does not use Edit or Edit Stop switches. In analyzing this missorting failure, false edit lights have appeared. Continue analysis of missorting failure.

S.H. #4. CEM 082-41, Burning Resistors. "A 15K, 2W Resistor, P/N 317098, is available to replace overloaded bias resistors which are susceptible to burning. All four 15K, 1/2W resistors must be replaced as soon as possible." Applies to all 083's between approximately HY and B1 suffix machines wired to F & G suffix W/D's.

S.H. #5. Intermittent missorting may be caused by flat areas or nicks worn into the first upper cork feed rolls because of jams at the first feed roll position. If this occurs, both the first upper and lower shafts should be replaced by the former style gear driven steel feed roll shafts. For further information and part numbers, refer to CEM-082-16.

S.H. #6. A maladjusted run out resistor will allow cards to remain in the transport at the end of a run. Quite often these cards are overlooked by the operator. When the next column is sorted, these cards stack and appear to have missorted. This condition will always show up as a "missorting" of the first few cards in the pocket.

S.H. #7. Intermittent missorting can be caused by a stretched cog belt between first and second feed rolls. This is a result of broken wires inside belt. A new style timing belt is available with nylon tension members rather than steel. It is identified by white strips visible on the edges of the belt.

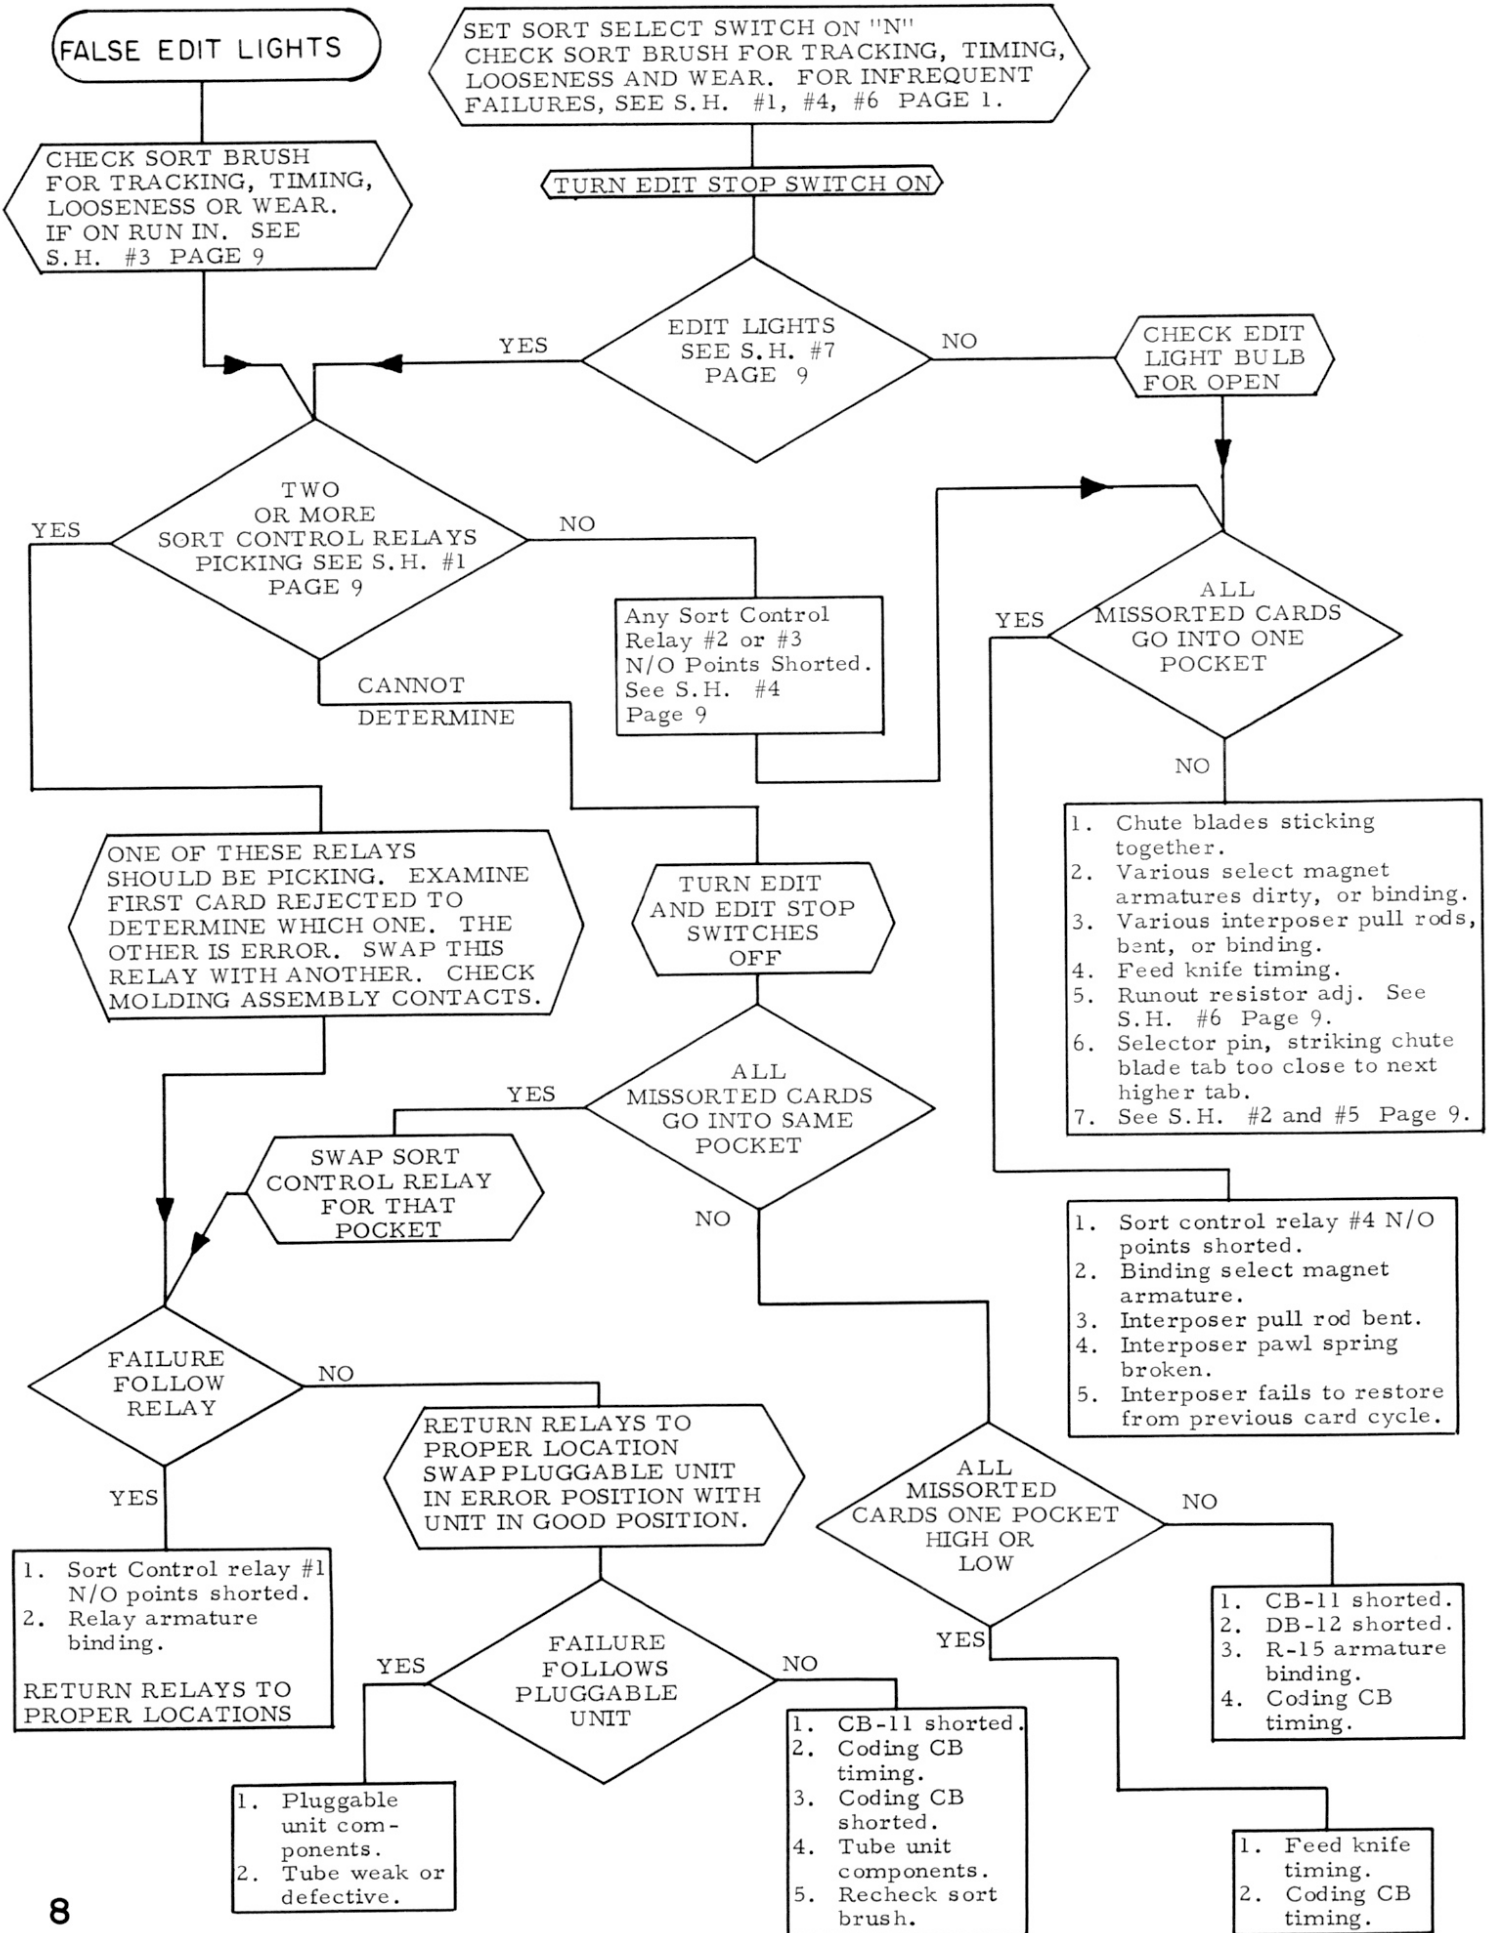
MISSORTING

S.H. #2. Intermittent missorting can be caused by a stretched cog belt between first and second feed rolls. This is a result of broken wires inside belt. A new style timing belt is available with nylon tension members rather than steel. It is identified by white strips visible on the edges of the belt.

S.H. #3. A false Edit condition can occur on running after digit suppress keys have been used on the previous sort. This occurs on machines wired to NO through E suffix W/D's. When digit suppress keys are depressed, tubes for suppressed digits can still conduct, but they are not extinguished, as the extinguishing impulse must come through the suppress switch, now open. After the suppress keys have been released, tubes which are conducting will pick their respective Sort Control relays as soon as Tube Transfer relay R-15 picks when machine is started again.

S.H. #5. Intermittent missorting may be caused by flat areas or nicks worn into the first upper cork feed rolls because of jams at the first feed roll position. If this occurs, both the first upper and lower shafts should be replaced by the former style gear driven steel feed roll shafts. For further information and part numbers, refer to CEM-082-16.

S.H. #6. A maladjusted run out resistor will allow cards to remain in the transport at the end of a run. Quite often these cards are overlooked by the operator. When the next column is sorted, these cards stack and appear to have missorted. This condition will always show up as a "missorting" of the first few cards in the pocket.

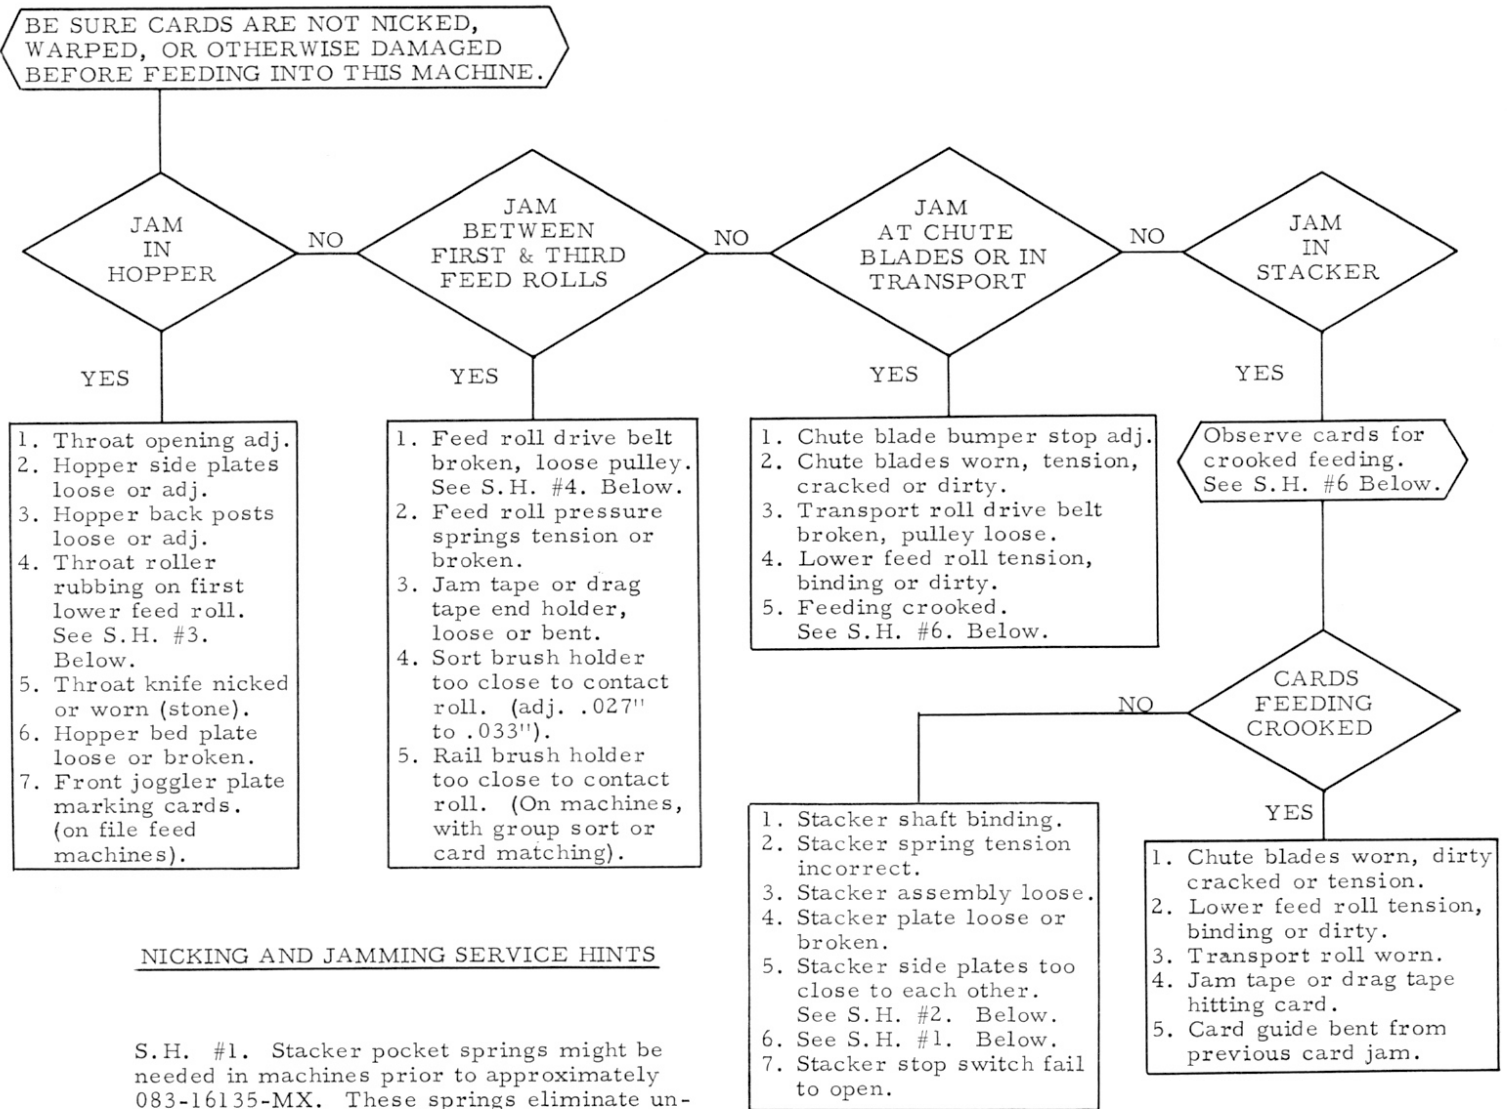
JAMMING

S.H. #1. Stacker pocket springs might be needed in machines prior to approximately 083-16135-MX. These springs eliminate uneven stacking and possibly nicking and jamming. See CEM-083-3.

S.H. #3. Intermittent throat jamming may be caused by the throat roller touching the first lower feed roll. If so, the Hopper Base Support Bar which mounts the roller block should be shifted to allow .010" clearance between the roller and the feed roll. The throat knife must now be readjusted.

S.H. #4. If transport drive belts, P/N 336258, break repeatedly, Drive pulleys, P/N 336176 should be checked to insure they have 19 teeth. A limited number of machines may have been shipped with 20 tooth pulleys installed throughout the drive. These must be replaced since they cause excessive strain on the belts.

S.H. #5. Feeding failures may be a result of feed knife marking of cards. It may be necessary to reverse the feed cams on the shaft. The timing hole in the cam should be toward the rear of the machine. This change may be needed on machines prior to 083-24098-EZ.

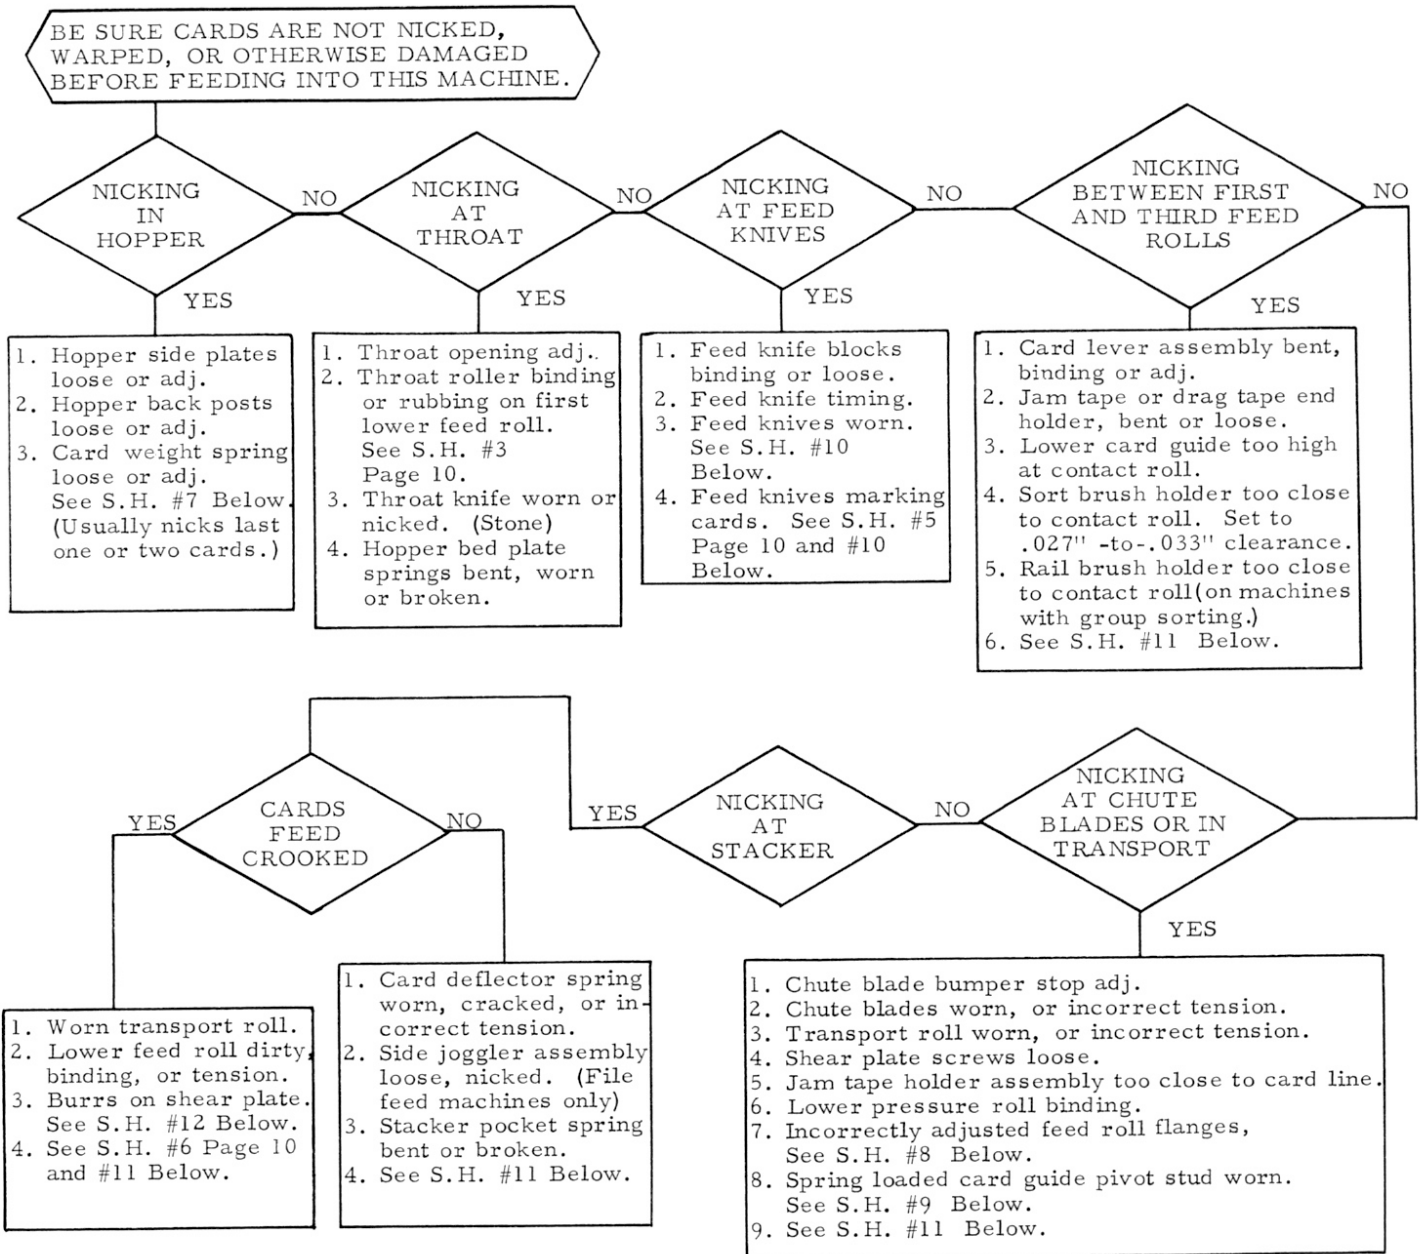
NICKING

S.H. #7. A loose card weight spring assembly, loose screws, or a maladjusted spring can cause nicking of the last card or two in the hopper. With the card weight out of the hopper, the spring should be adjusted so that the distance between the end sections (Which rest on the feed knives) and the bottom of the weight itself is $5/32''$ plus $1/32''$ or minus $1/16''$. Should the spring assembly mounting screw holes be stripped, replace the card weight with P/N 336675 which has been redesigned to include a threaded metal insert, which is used to attach the spring assembly.

S.H. #8. Fourth & fifth upper feed rolls on some machines with large lower idler rolls may have improperly adjusted steel flanges. If flange is too close to idler roll, it may cause creasing of card. If necessary, loosen set screws and shift flange.

S.H. #9. Nicking can sometimes be caused by slight grooves in lower card guide. Groove is result of lateral movement of spring loaded front guide, when its pivot stud has worn. When replacing, always use flipper P/N 223797 which contains a bronze pivot insert.

S.H. #12. A small number of machines prior to P1 Suffix may contain small burrs on stacker shear plates. This can cause nicking around column 40 on the 9 edge of the cards. Stone these burrs. (CEM 082-80, Item 1)

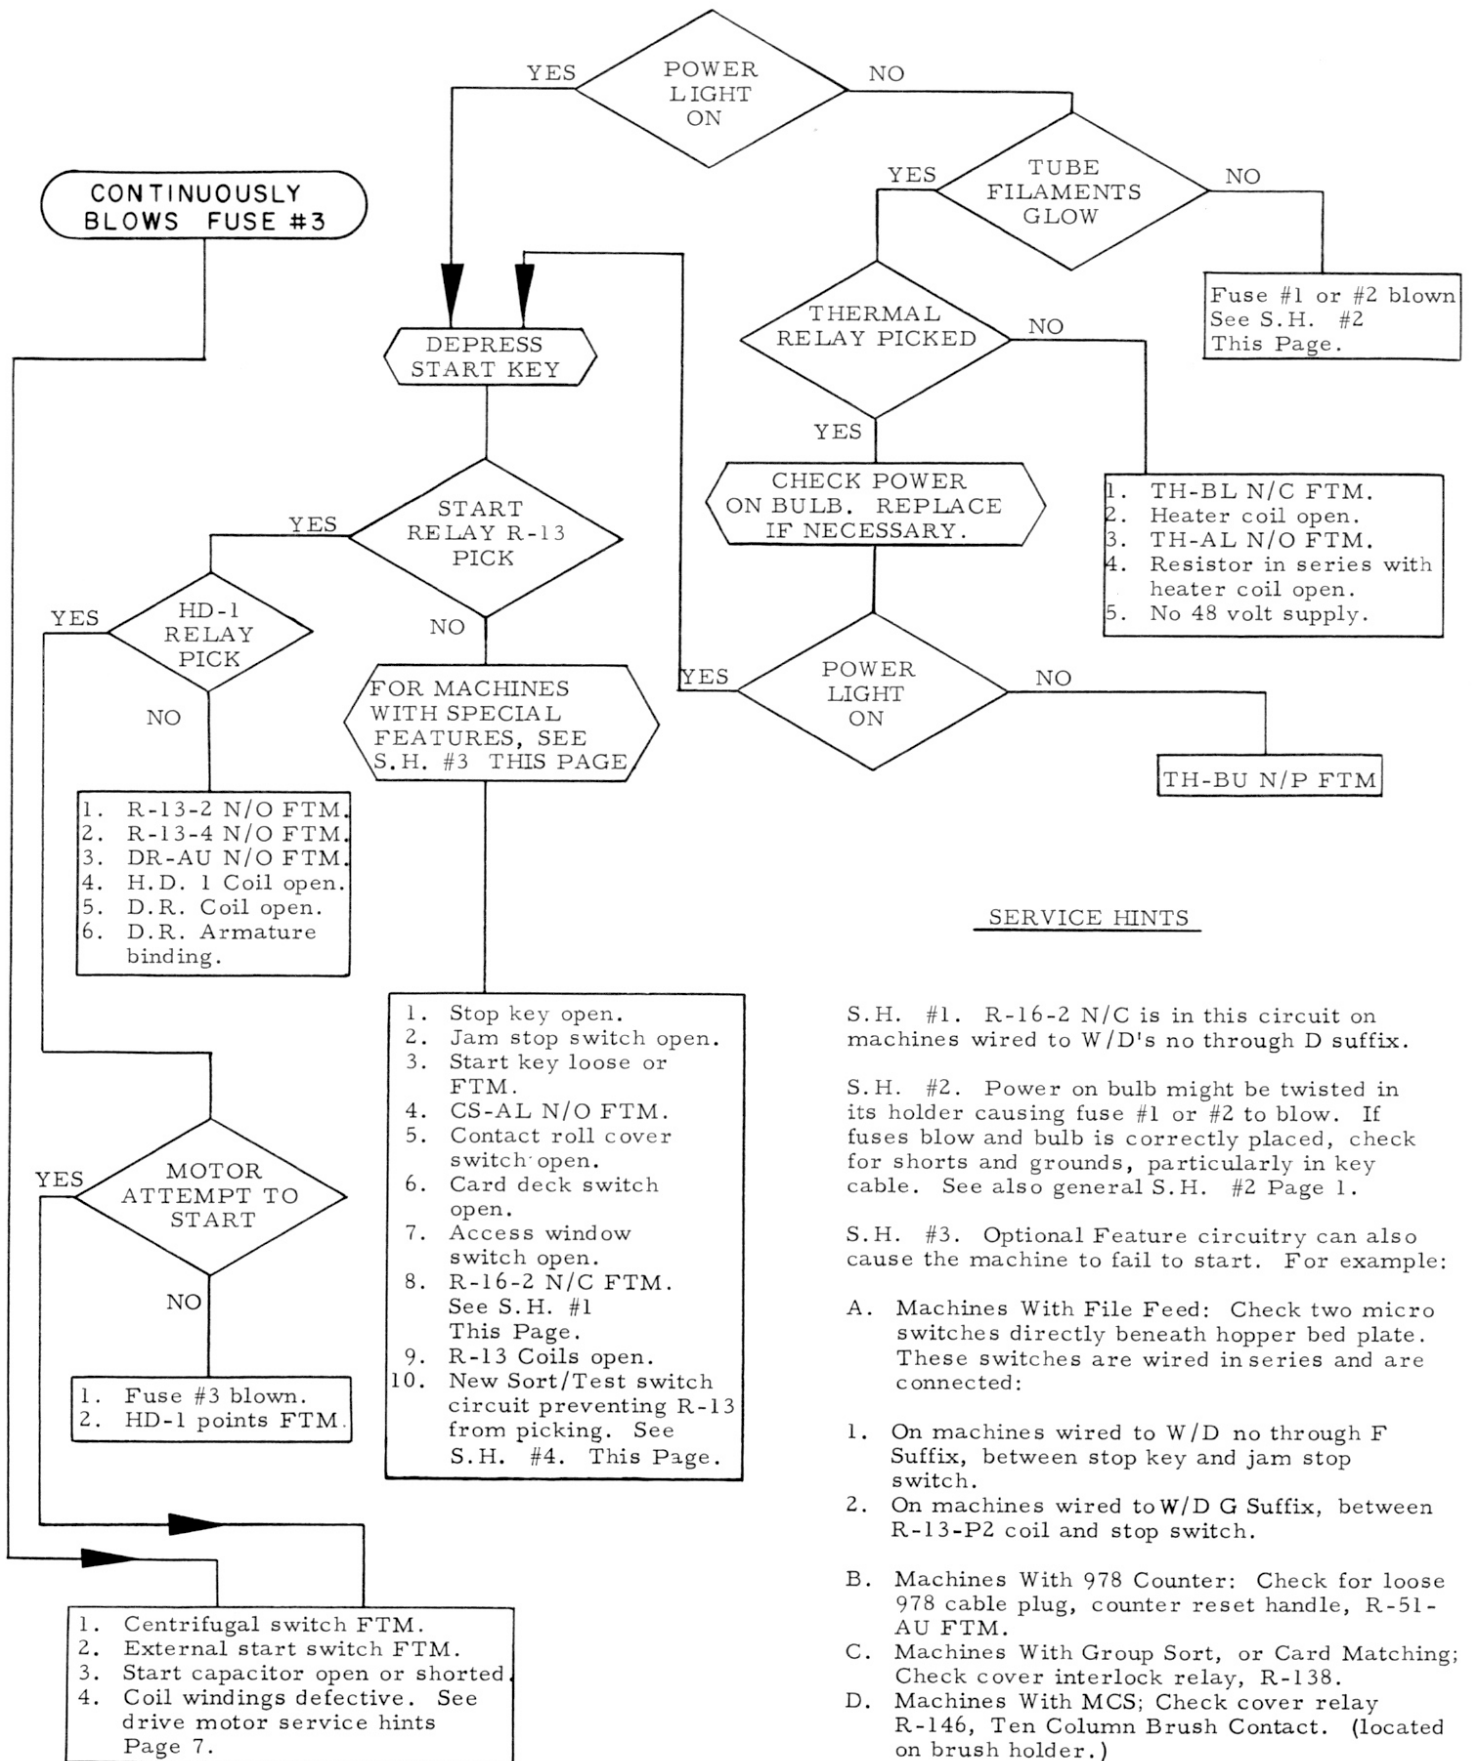
FAILING TO START

S.H. #1. R-16-2 N/C is in this circuit on machines wired to W/D's no through D suffix.

S.H. #3. Optional Feature circuitry can also cause the machine to fail to start. For example:

- A. Machines With File Feed: Check two micro switches directly beneath hopper bed plate. These switches are wired in series and are connected:
1. On machines wired to W/D no through F Suffix, between stop key and jam stop switch.
 2. On machines wired to W/D G Suffix, between R-13-P2 coil and stop switch.
- B. Machines With 978 Counter: Check for loose 978 cable plug, counter reset handle, R-51-AU FTM.
- C. Machines With Group Sort, or Card Matching; Check cover interlock relay, R-138.
- D. Machines With MCS; Check cover relay R-146, Ten Column Brush Contact. (located on brush holder.)

S.H. #4. Machines starting with K2 suffix incorporate a circuit change which prevents the machine from starting if the Sort/Test switch is set at Test.

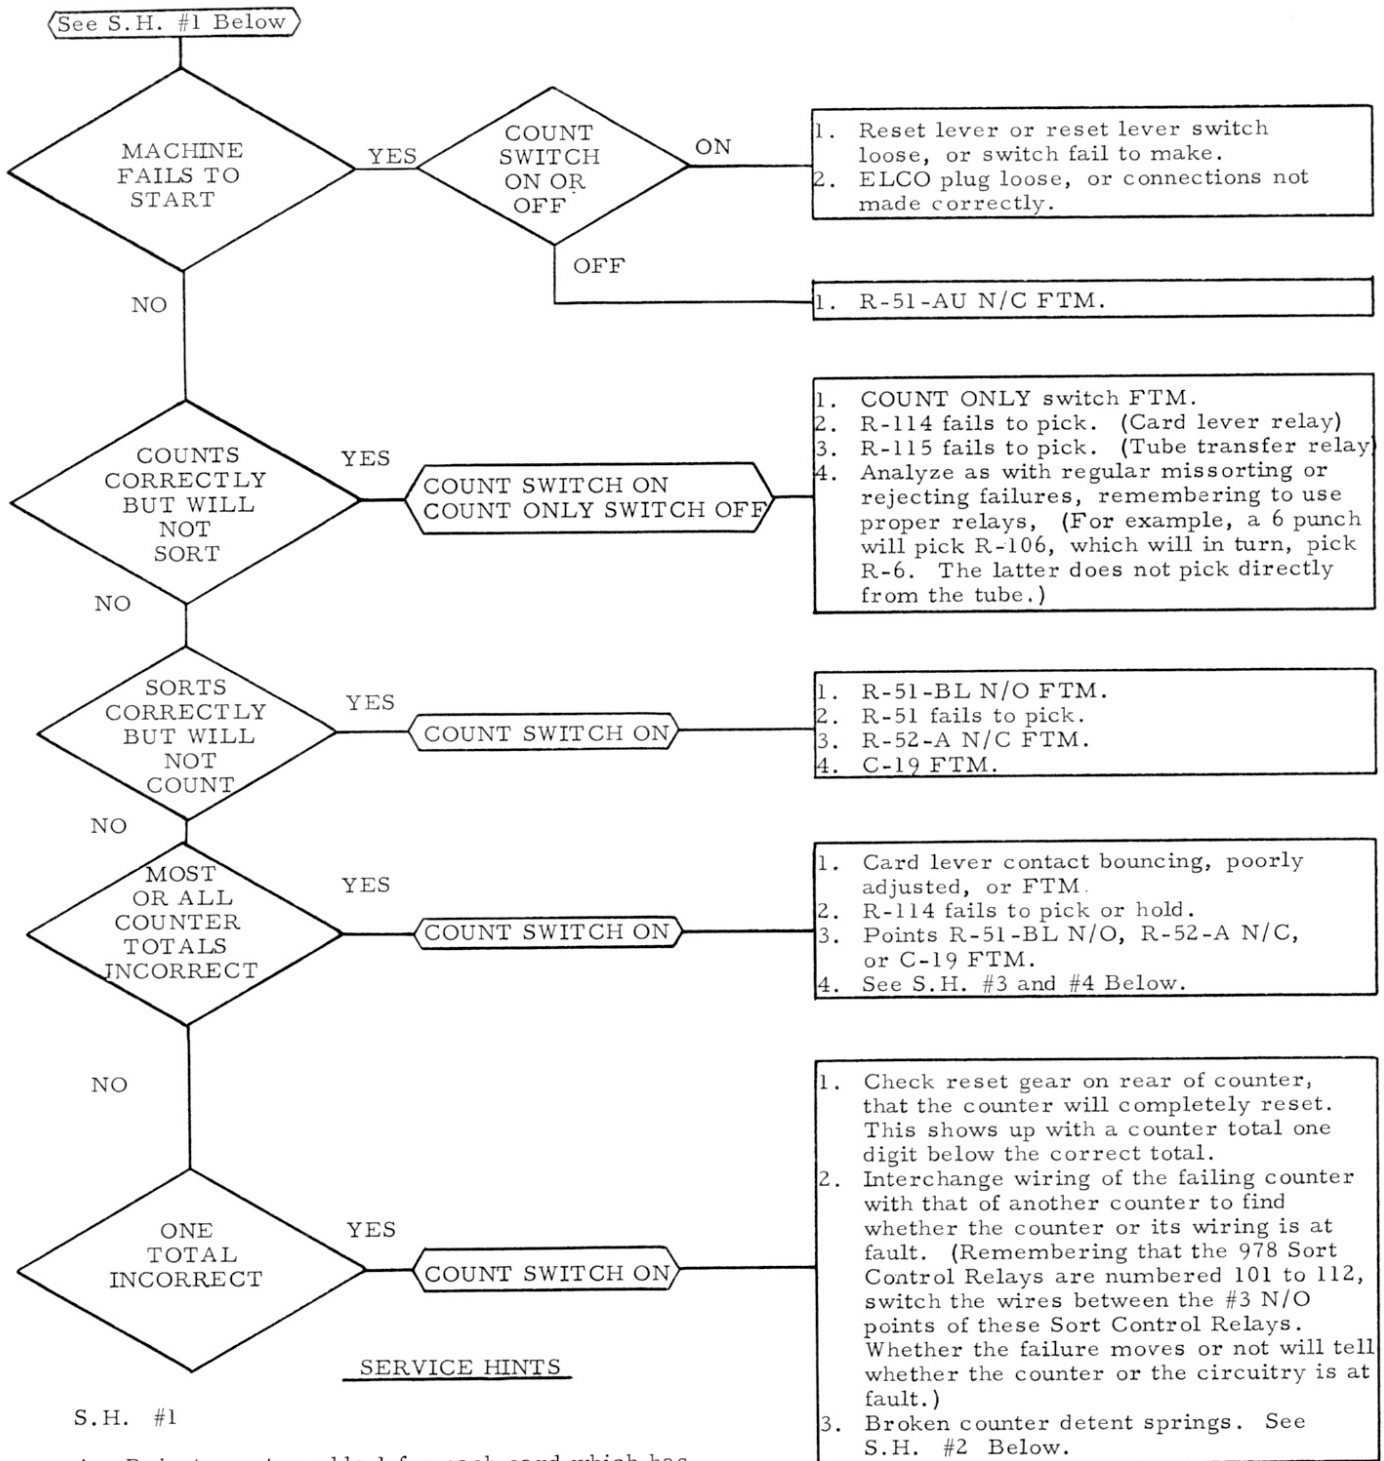
978 COUNTER FAILURES

- A. Reject counter adds 1 for each card which has not had at least one punch read.
- B. Subtotal counter adds 1 for each card that passes through the machine.
- C. Counters 1 through 12 add all card punches read. If a counter adds extra numbers, it is quite possible two punches are being read from one card, possibly from an adjacent column. Check sort brush tracking.

S.H. #2. Incorrect totals can be caused by broken Detent Springs on Counter. These are the flat blue-steel springs which hold the counter shaft in a de-tented position. Detent spring P/N 144076 should be installed when breakage is experienced. Older counters contain only one detent spring while newer ones contain two. When breakage is experienced, two springs must be installed in both style counters.

S.H. #4. A possible wiring error on machines prior to C1 suffix wired to W/D 336001 G can cause breakage of Counter Reset Detents. This wiring error can cause the Reset Switch to be ineffective and can allow the counters to be re-set while voltage is applied to counter magnets. To correct this condition, remove jumper from R-14-P2 coil common to DR coil common. Indicate wiring change on machine W/D.

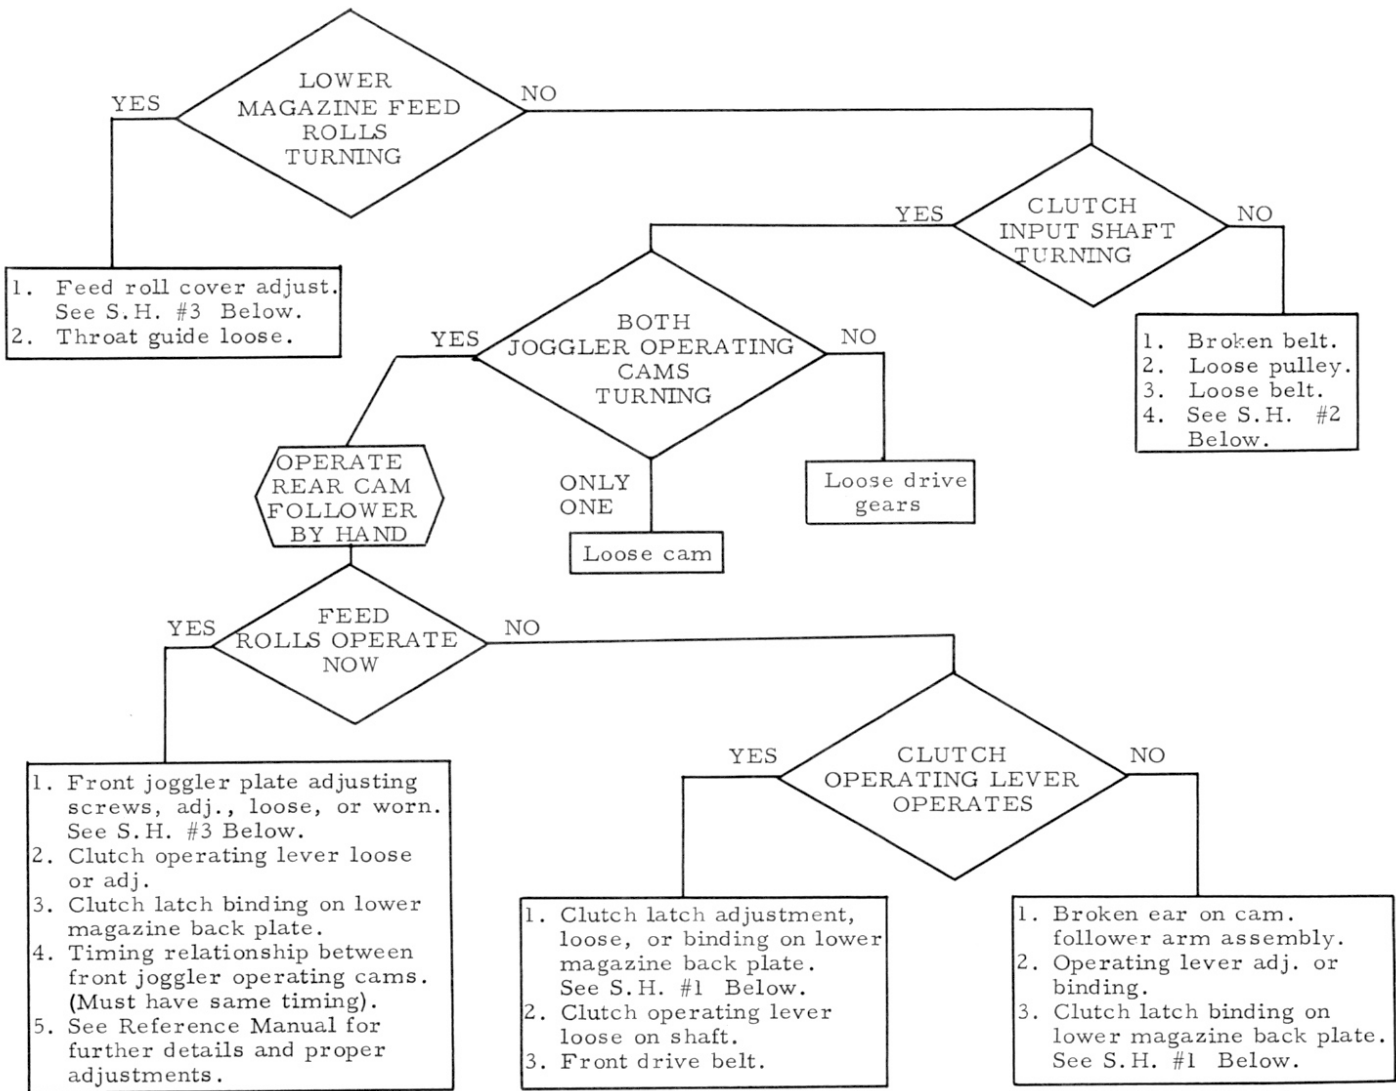
FILE FEED FAILING TO FEED

S.H. #1. Newer models of the 083 have the clutch latch undercut, and do not experience this trouble. On older models, when this binding is experienced, remove, shim, and replace the lower magazine back plate in position so there will be a slight clearance between the latch and the back plate.

S.H. #2. If a drive belt is slightly loose, trouble might appear only when the file feed tray is full of cards. Replace the front drive belt.
