IBM Customer Engineering

SERVICE INDEX

Sorter

IBM 083 SERVICE INDEX

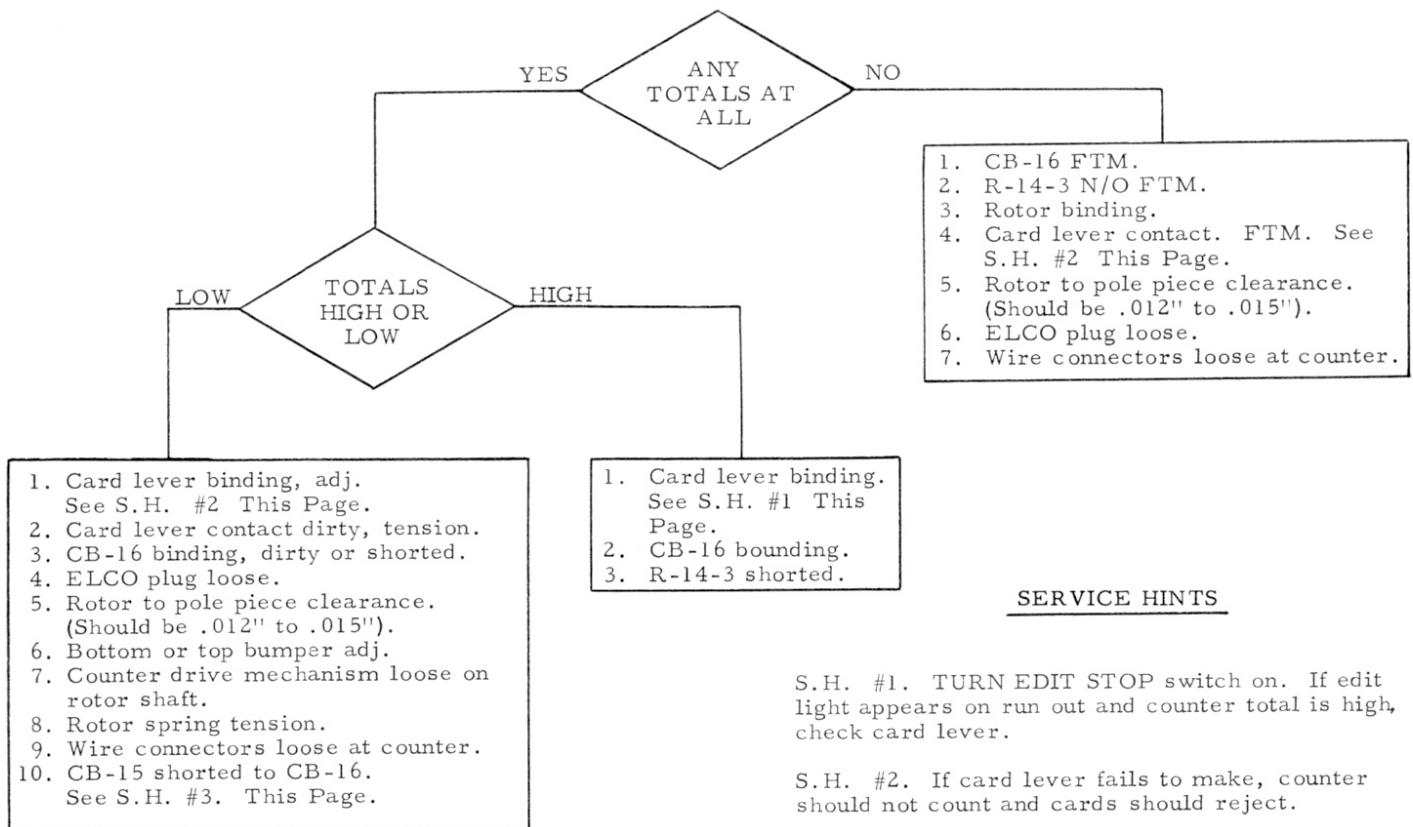
AUXILIARY CARD COUNTER FAILURES *

S.H. #1. TURN EDIT STOP switch on. If edit light appears on run out and counter total is high, check card lever.

S.H. #2. If card lever fails to make, counter should not count and cards should reject.

S.H. #3. A short between CB-15 and CB-16 can be caused by burrs on the CB's and can result in shorting 48 volts to the counter after CB-16 breaks, thereby undercounting.
